# WET WING FUEL SELECTOR VALVE LEAKAGE

by Eric Lightsey, TTCF Member

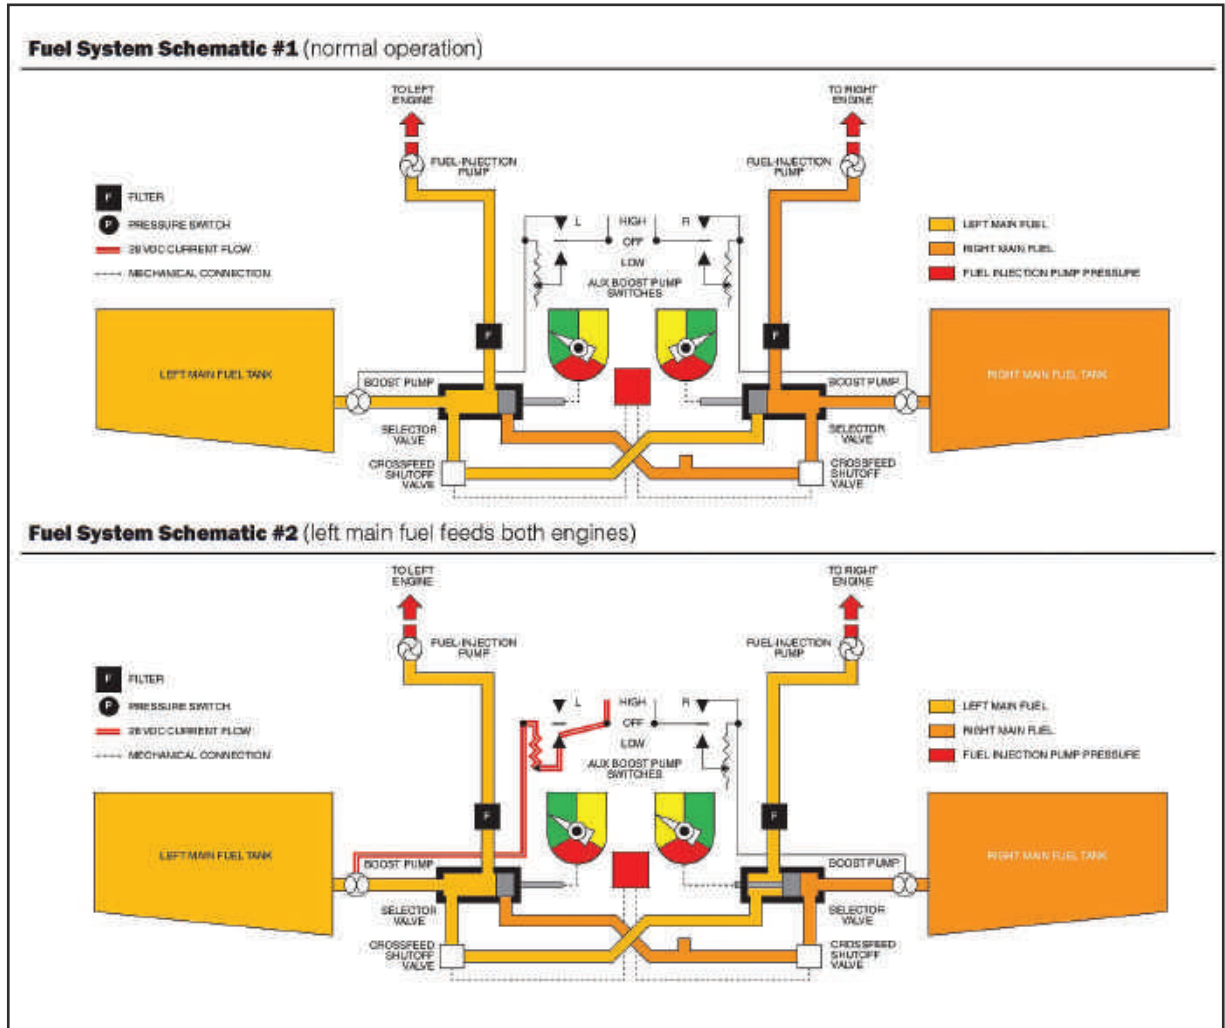
Fuel system graphic courtesy of SIMCOM. Top panel shows system in normal operation. Bottom panel shows right engine cross feeding off the left tank.

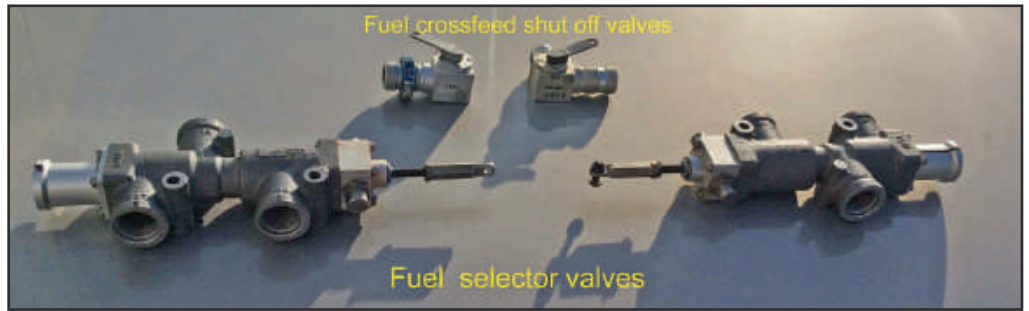
*This is what the valves look like when removed. Check your logbooks to see when yours were last overhauled. Can you feel a well-defined detent?*

Back to my 414A. Prior to overhaul of the fuel selector valves, the left fuel selector handle was spongy when moved to left main. A definite detent could not be felt. The external actuating mechanism for both fuel selector valves was lubricated which resulted in some improvement of the subjective detent feel.

No logbook entry for the left fuel selector valve was found, so it likely had the same time in service as the airframe, approximately 7,000 hours. The right fuel selector valve had been overhauled in 2004.

Both fuel selector valves (9910201-1) were sent for overhaul by Aircraft Accessories International in Peachtree City, GA. Richard Hewitt overhauled them and advised that the internal pistons were extremely difficult to move from one position to another upon arrival. Over 22 pounds of force was required to break detent when they came in, but after overhaul, they would break detent at less than 15 pounds. Cost to overhaul was \$375 each. All of

After re-installation, both fuel selector valves now had a definite detent that could be felt when repositioning the handle.

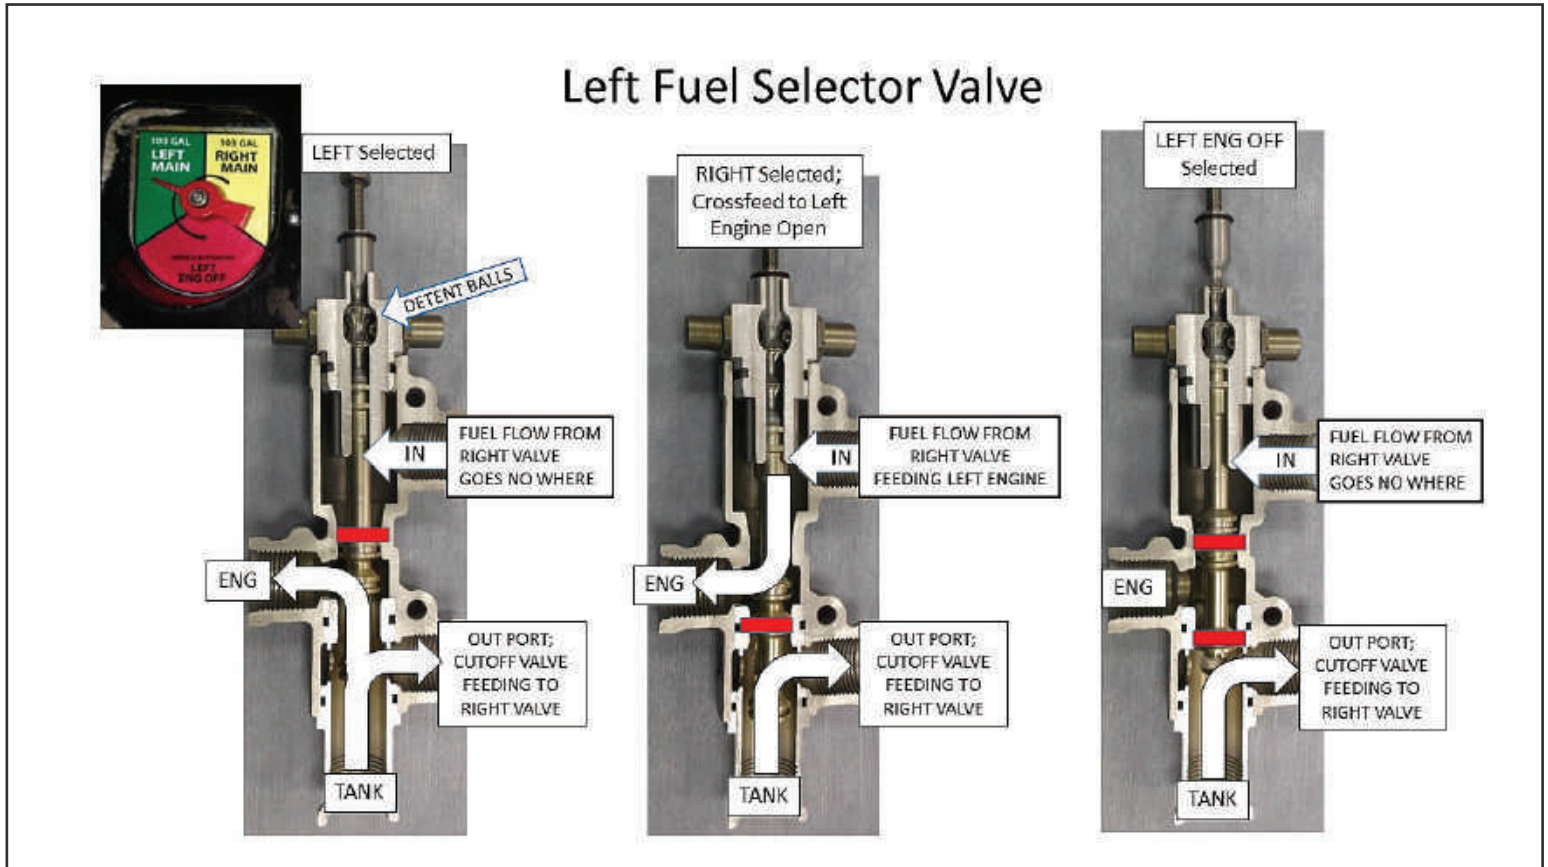
*These pictures illustrate how fuel flows through the left fuel selector valve in various tank selection scenarios. The potential problem with the left valve pictured would be that if the piston did not move all of the way toward left main, fuel from the right valve that was supposed to “go nowhere” can cross the red line pictured and unintentionally feed the left engine. If the external mechanism is not lubricated, the detent balls may not be felt and the pilot will not be able to position the piston correctly. Even if the piston is positioned correctly, that won't stop the wrong flow if the internal seals leak.*

when returning to a tank to engine configuration if a fuel selector valve does not completely move, or it is leaking internally.
